NATIONAL TRANSPORTATION SAFETY BOARD

MATERIALS LABORATORY FACTUAL REPORT

Report No. 21-081

Place : Pine Grove, Oregon
Date : August 23, 2020
Vehicle : Kaman K-1200, N314
NTSB No. : WPR20LA283
Investigator : Fabian Salazar, ASI-WPR

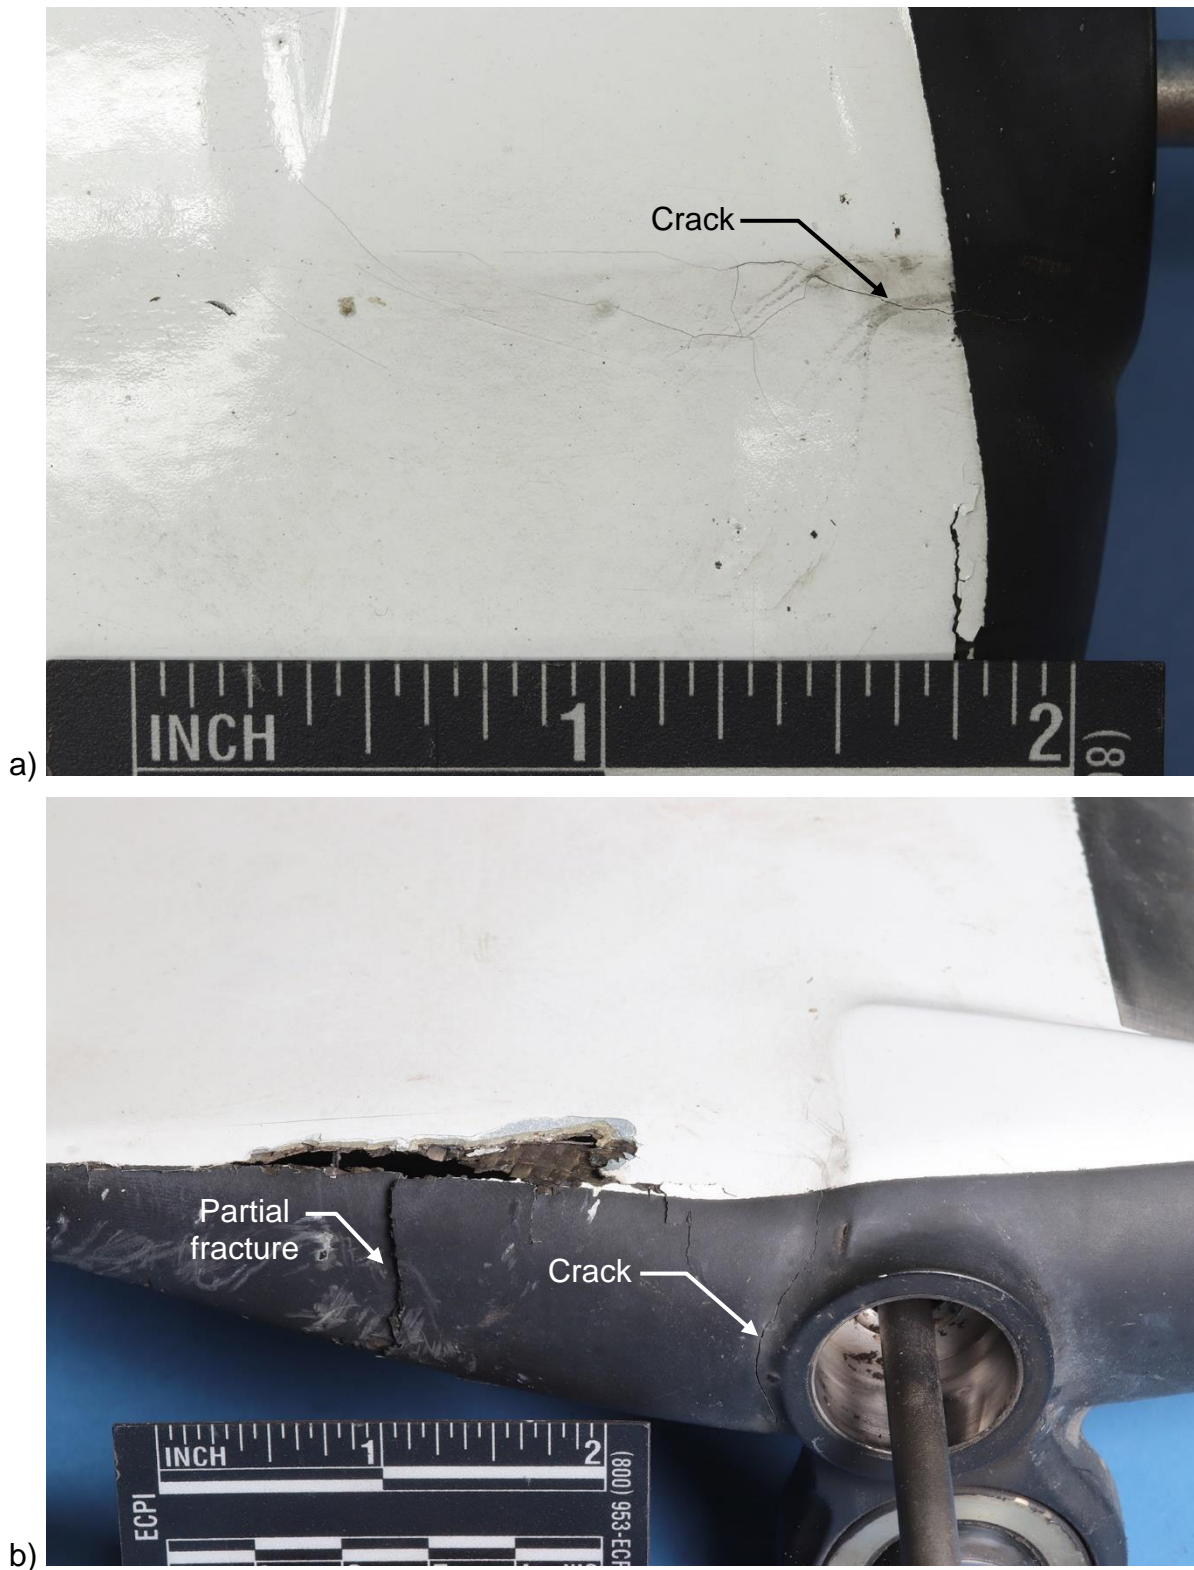
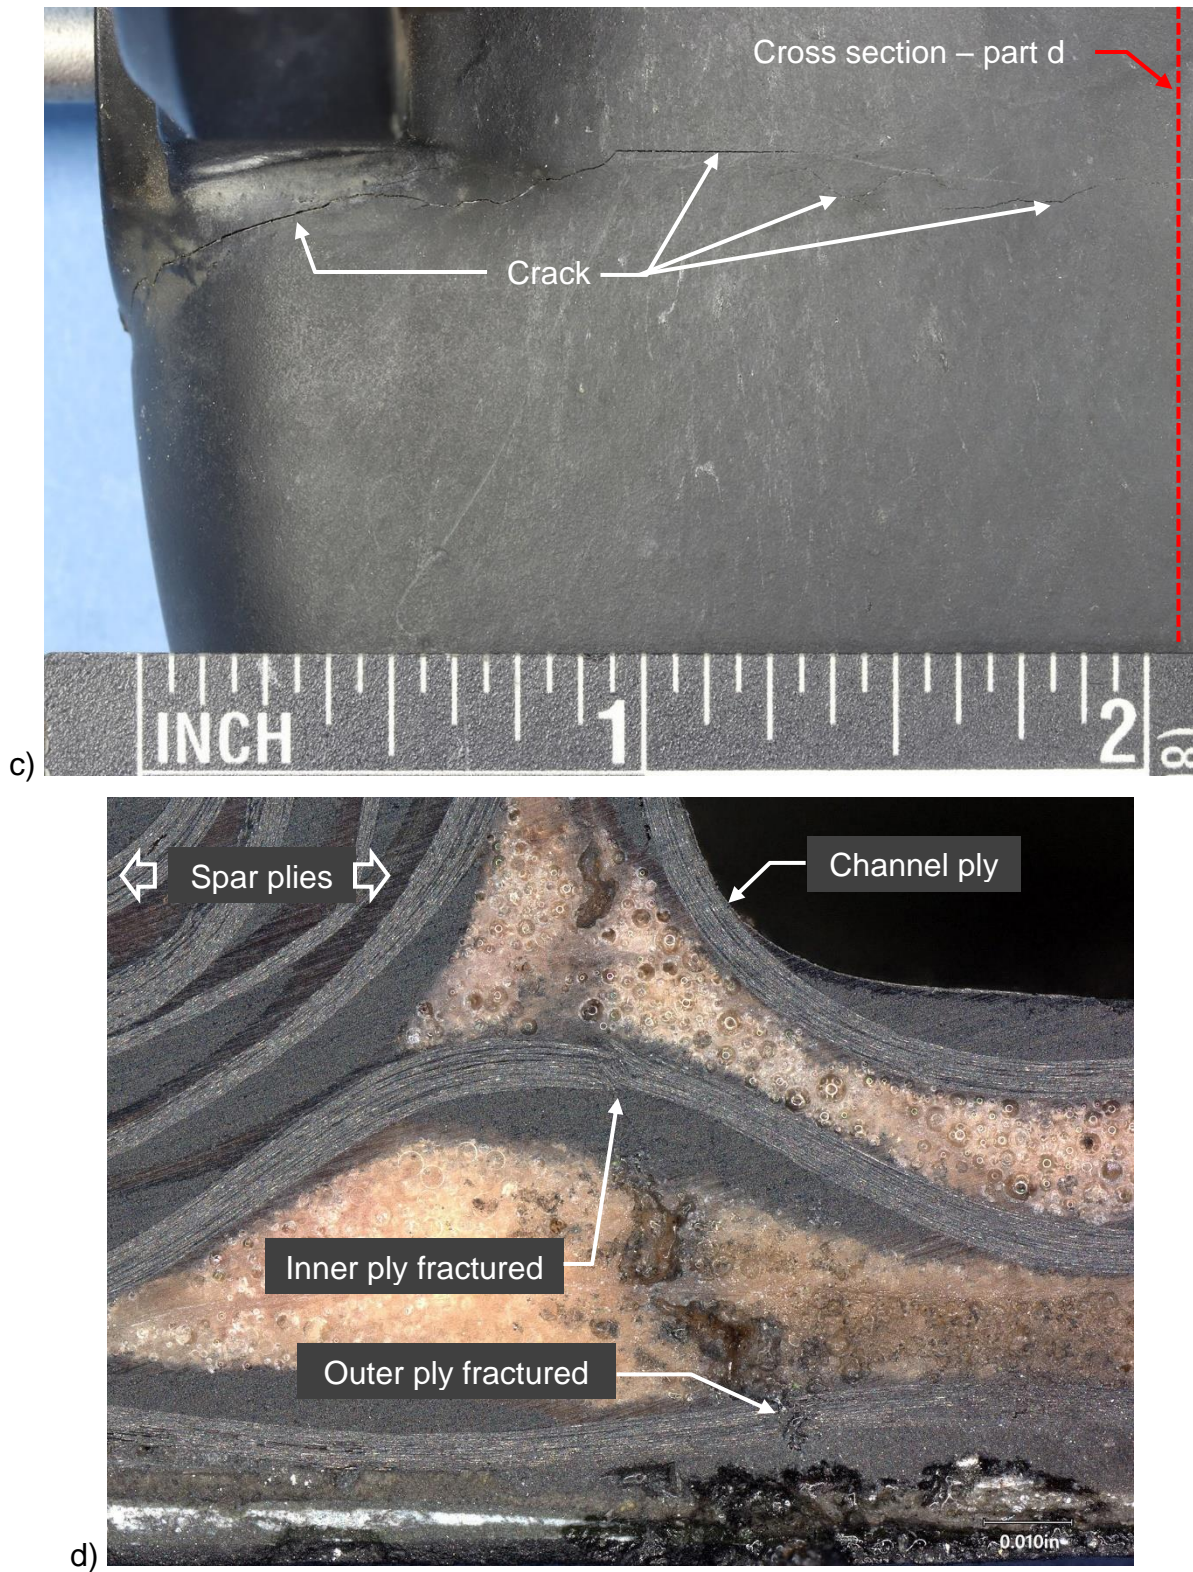
The sister flaps from the accident aircraft were examined for visual signs of cracks, particularly around the inboard closeout and the bond between the closeout and aluminum fitting was evaluated. Overview images of the LHR, RHW, and RHR servo flaps are shown in figures 37a – c, respectively. The RHR flap had indications of foreign body contact on the outboard portion of the upper skin between STA 25 and 30. All flaps exhibited cracking along the bond line between the closeout and the aluminum fitting, but the extent of cracking varied. The LHR flap inboard closeout exhibited a hairline crack that extended approximately 1 inch along the upper surface and halfway down the inboard side of the flap, as seen in figure 38. The RHW inboard closeout cracks extended approximately 1 inch along the upper surface, wrapped around the inboard side, and extended approximately 0.6 inch along the lower surface, as seen in figures 39a – c. The RHR inboard closeout cracks extended approximately 0.5 inch along the upper surface, wrapped around the inboard side along the bond line, and extended approximately 1.7 inch along the lower surface, as seen in figures 40a – c. The closeout had sustained damage as seen in figure 40b. There were holes through the upper and lower surfaces and the closeout was partially fractured between the holes. The inboard ends of the flaps were sectioned as described below. The RHR flap was cut along the red dashed line in figure 40c, which passed through a crack along the underside of the flap. The cross section through the crack, shown in figure 40d indicated that the outer and inner skin plies were fractured beneath the surface crack.

Figure 40. Images of cracks along edge of inboard closeout bond line on RHR servo flap: a) top side of closeout; b) inboard side of closeout;

Figure 38 (cont.). c) lower side of closeout; and d) cross section through lower skin plies at location indicated in part c. The surface crack extended through the outer ply and inner ply.

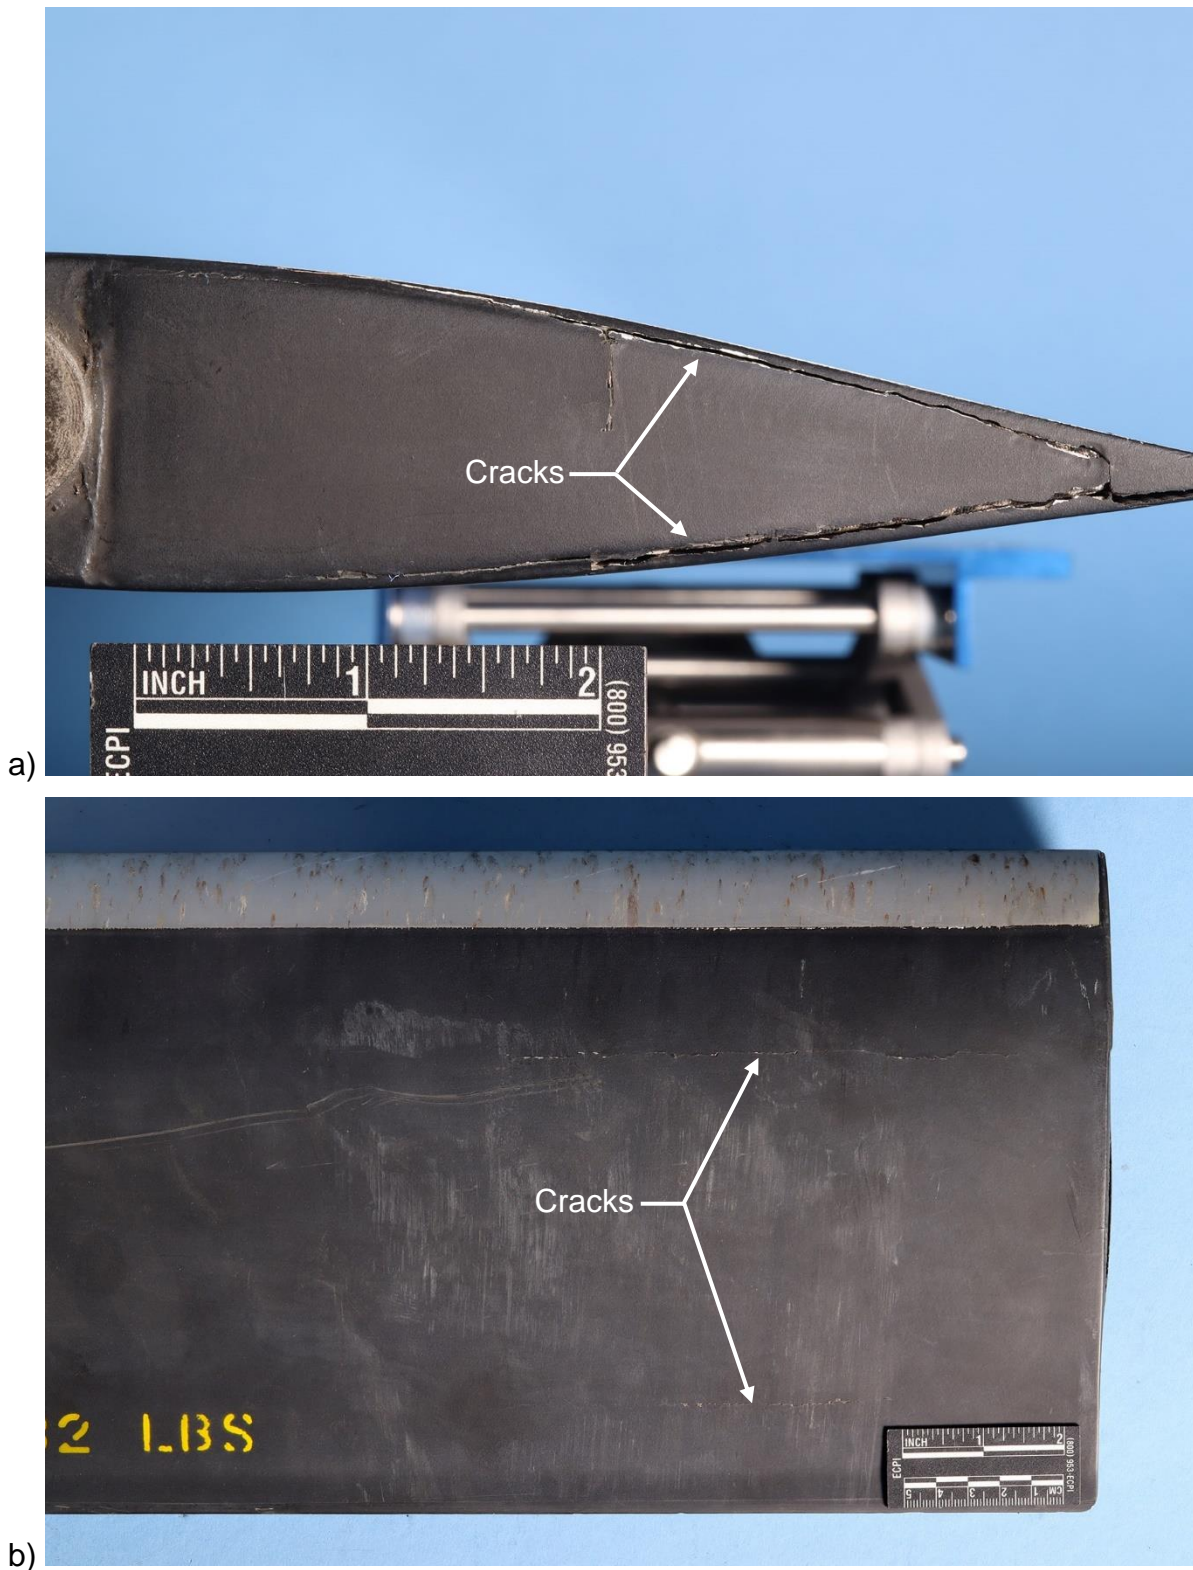
Additional damage was observed at the outboard end of the RHR servo flap. The outboard closeout had cracked along the upper and lower bond lines (figure 41a). The cracks started near the mid-afterbody I-beam and extended forward and aft. The lower afterbody skin was cracked in the spanwise direction at the outboard end (figure 41b). One crack coincided with the trailing face of the D-spar and the other crack coincided with the forward end of the trailing edge strip.

Figure 41. Images of RHR servo flap: a) cracks along upper and lower edges of outboard closeout and b) spanwise cracks along outboard end of lower surface. One crack was at or near the aft end of the D-spar and the other was at or near the forward end of the trailing edge.

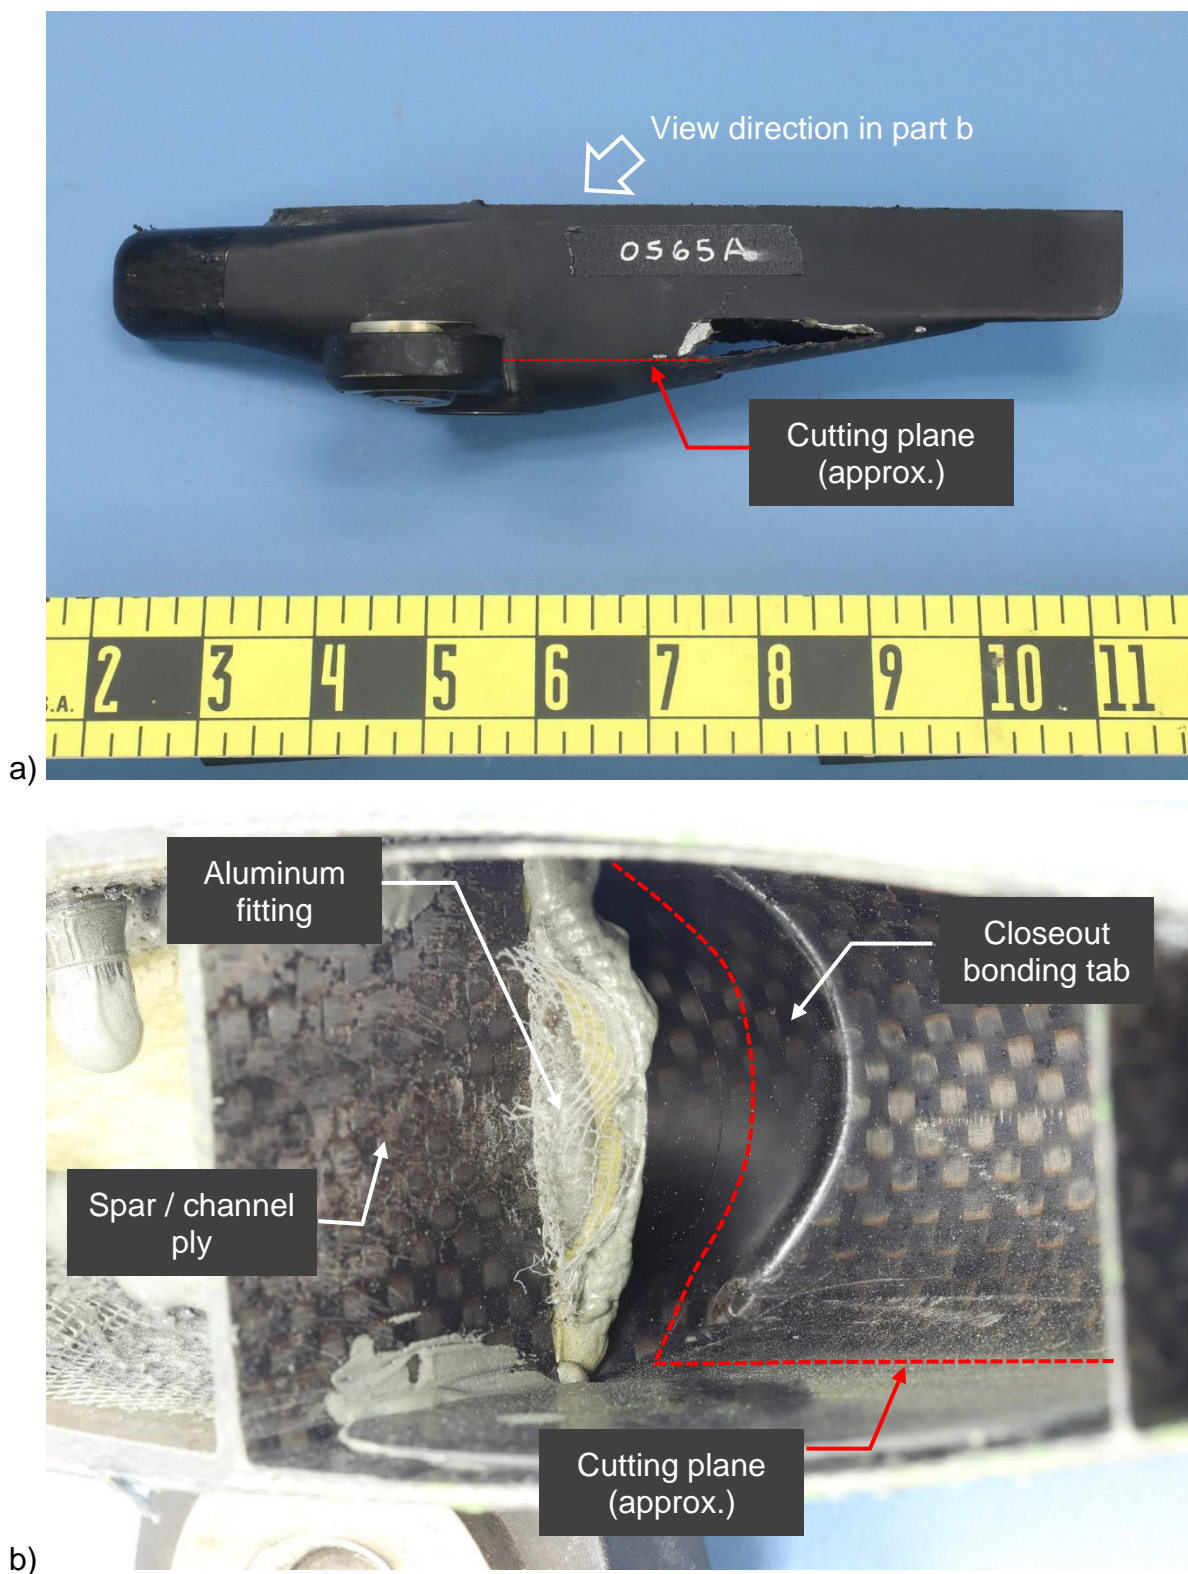
The bond between the inboard aluminum fitting and the bonding tab on the inboard closeout was evaluated on cross sections through the bond for the sister flaps. The inboard ends of each flap were sectioned, as shown for the RHR flap in figure 42a. Figure 42b shows a view inside the cut end with labels for the bonding tab, aluminum fitting, and spar. The closeout cavity was filled with a slow cure epoxy, the flap piece was cut down as required, and the closeout was sectioned using a wet abrasive saw down the midline of the bond, as indicated in figures 42a and b. The cross section through the LHR servo flap closeout bond is shown in figure 43 and the cross sections through the RHW and RHR bond are shown in figures 44a and b, respectively. All bonds exhibited voids along the bond line. The relative fraction of voids was compared by measuring the total bond line length along the cross section, measuring the length of voids along the line, summing the void lengths, and calculating the ratio of total void length to total bond line length (see figure 45 for an example of void length measurement).¹ A similar measurement was performed on the LHW servo flap, but on a plan view image of the closeout fracture. The void length ratios for the LHW, LHR, RHW, and RHR servo flaps were 0.827, 0.563, 0.517, and 0.751, respectively.

Figure 42. a) Sectioned inboard end of the RHR servo flap (S/N: 0565A) and b) view inside the sectioned end showing the closeout to aluminum fitting bond and the location of the cutting plane.

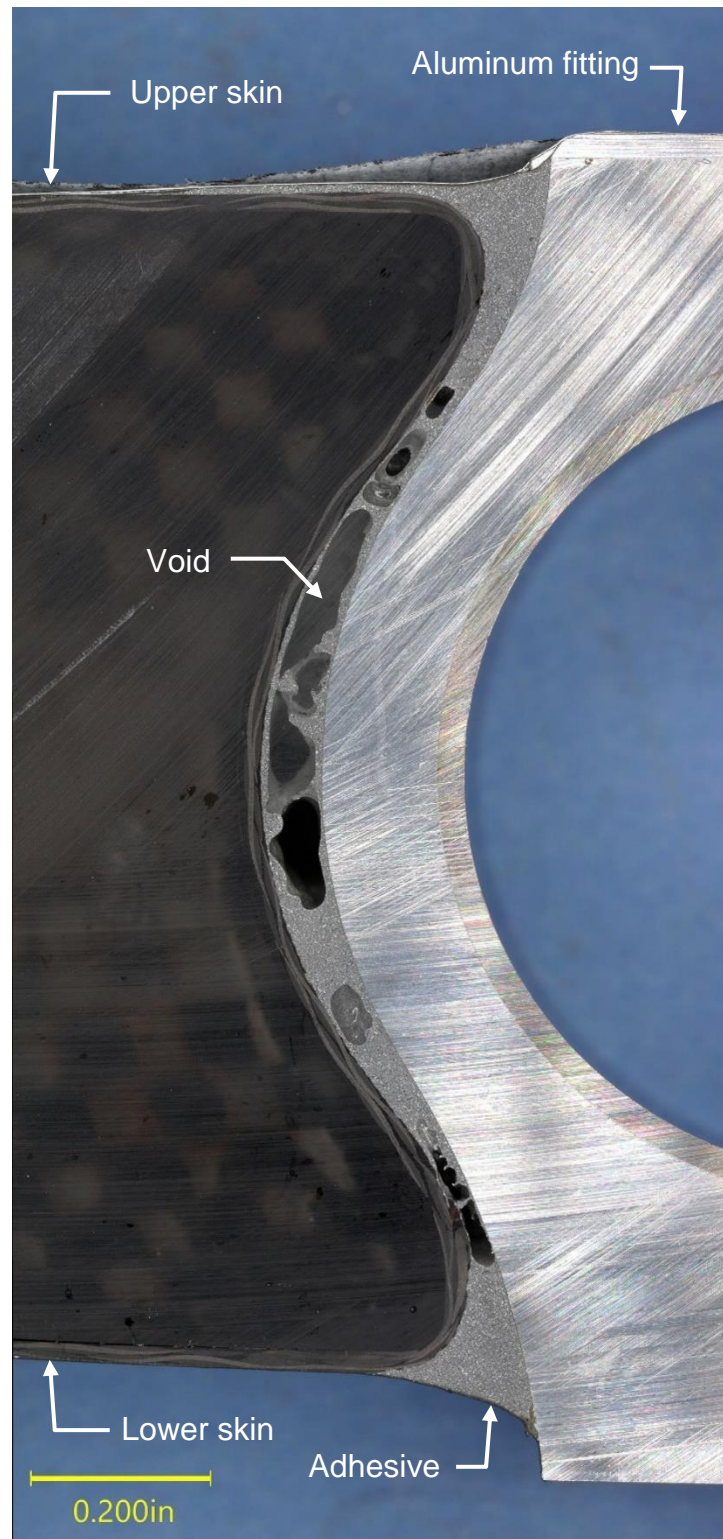
Figure 43. Cross section through LHR servo flap inboard closeout bond.

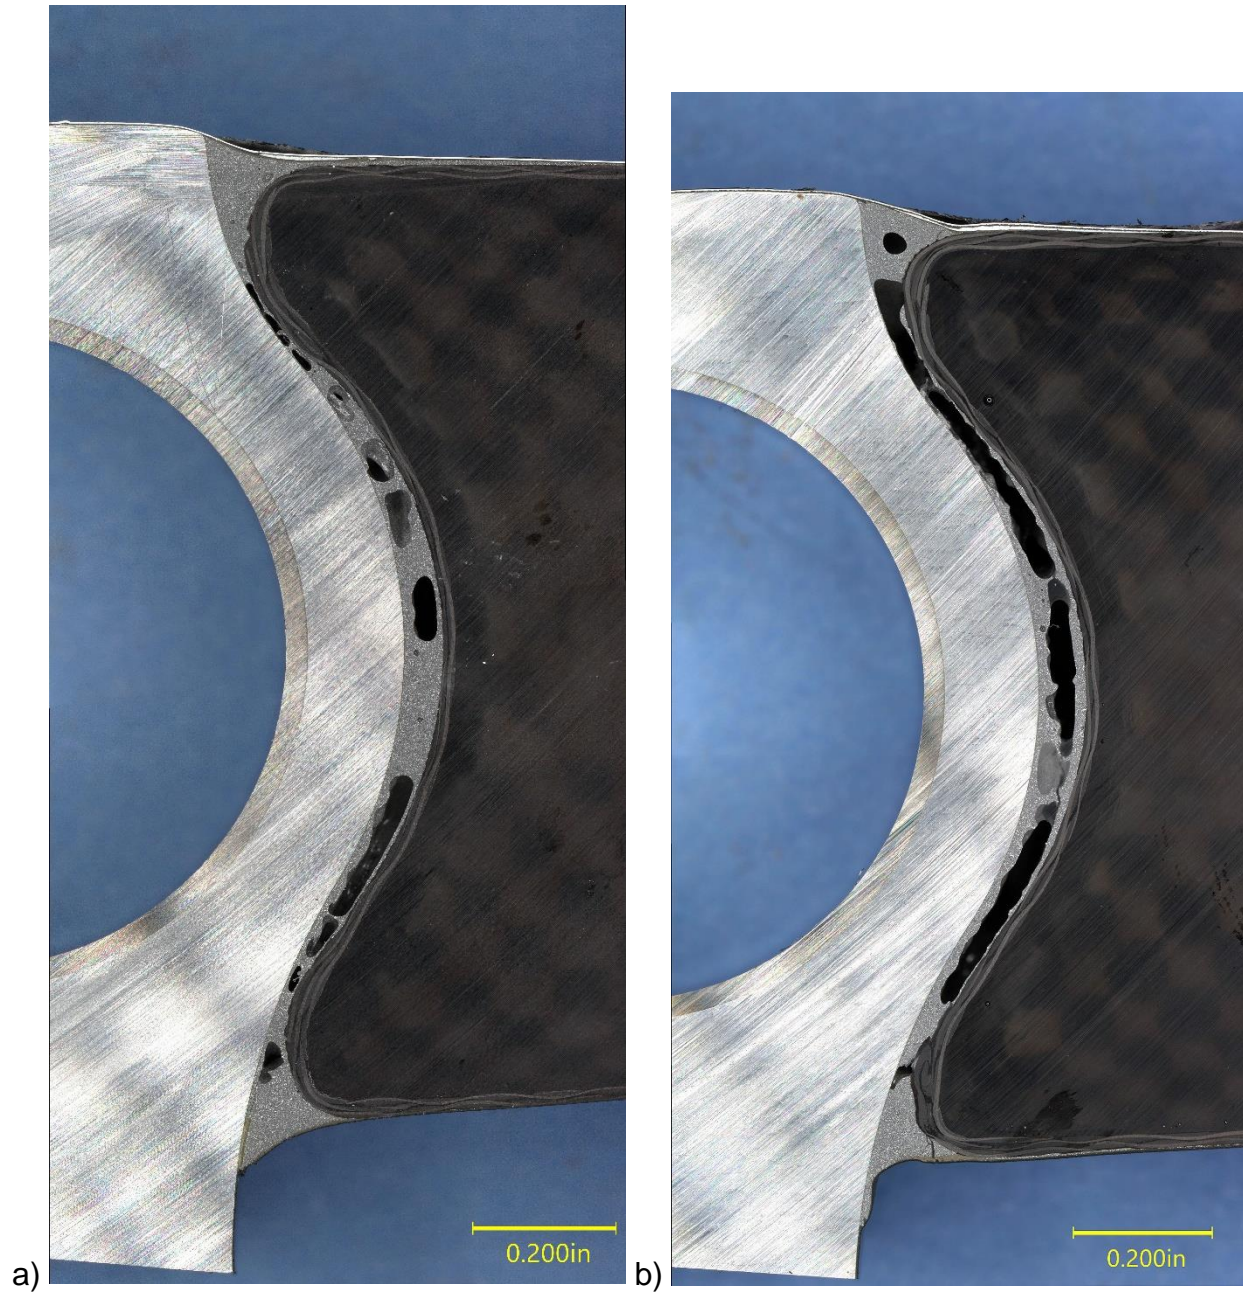
Figure 44. Cross sections through servo flap inboard closeout bonds: a) RHW and b) RHR.

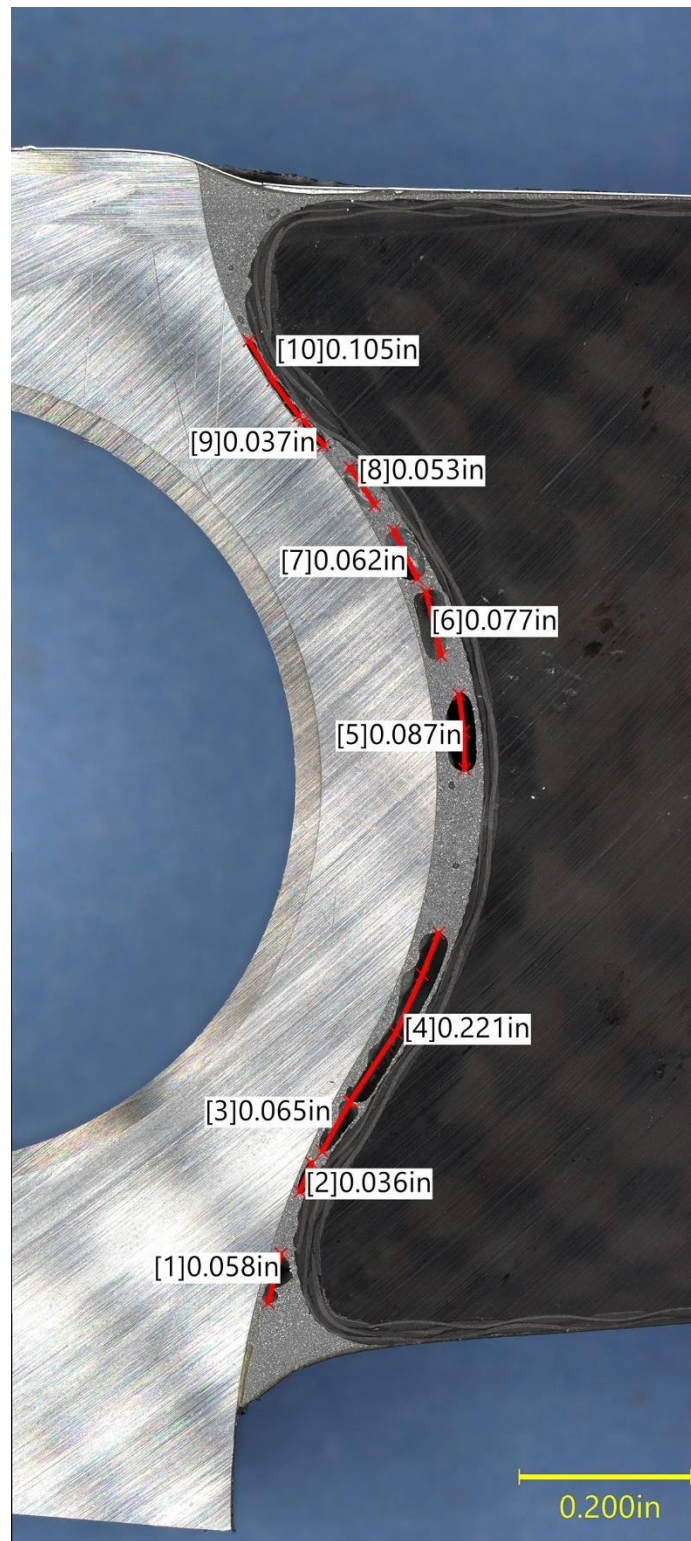
Figure 45. Example of void length measurement on the RHW servo flap inboard closeout bond.
